**Report: Chilt/RF11054 Revision A**

**A fire resistance test performed on 2No.  
single leaf single acting doorsets**

**Test conducted in accordance with  
BS 476: Part 20/22: 1987**

**Prepared for: Firestop Manufacturing  
Ltd  
4 Wyvern Buildings  
Grove Industrial Estate  
Dorchester  
Dorset  
DT1 1ST**

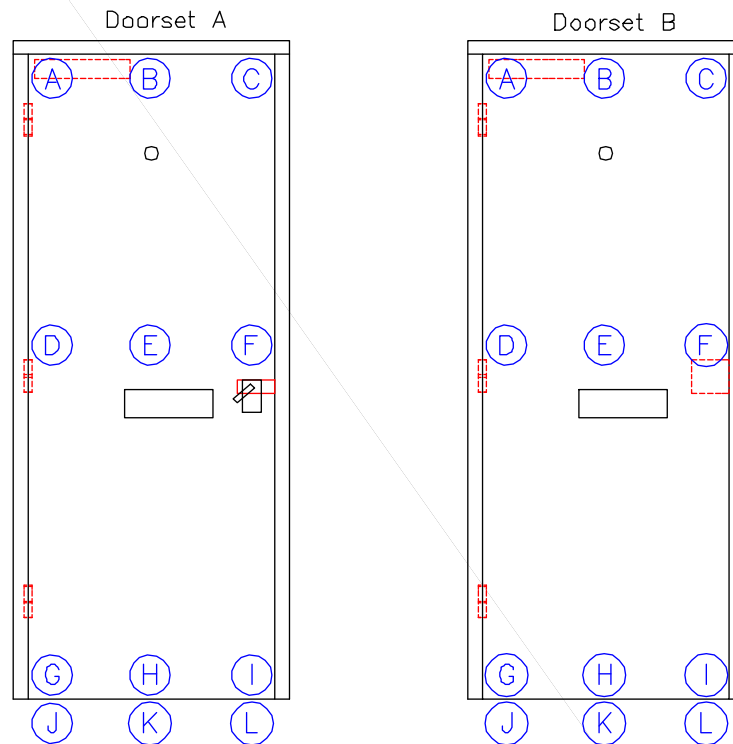
The following tables show the distortion of the doors in mm with an accuracy of  $\pm 1$ mm.

A positive measurement indicates distortion towards the furnace.

A negative measurement indicates distortion away from the furnace.

J, K and L give vertical movement of the door, a negative reading indicates that the door has dropped.

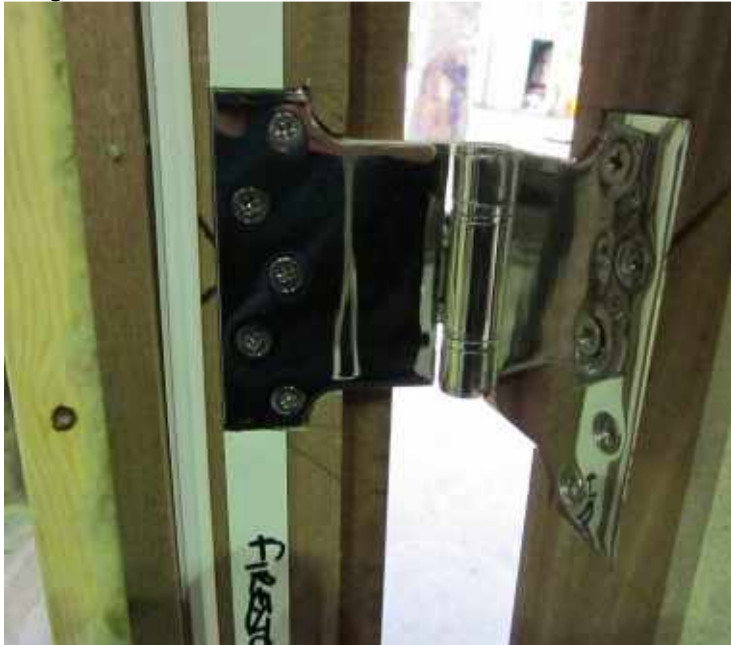
Hinge – doorset A

| | Make/type | Size (mm) | Location |
|---|---|---|---|
| Around hinges | Fully interrupted | - | Hinge blade fully interrupts seal in frame reveal |
| Under hinge blade | Firestop Manufacturing Ltd<br>intumescent sheet material<br>Product reference FS318 | 0.8 thick | Fitted under the hinge blade on frame and leaf |

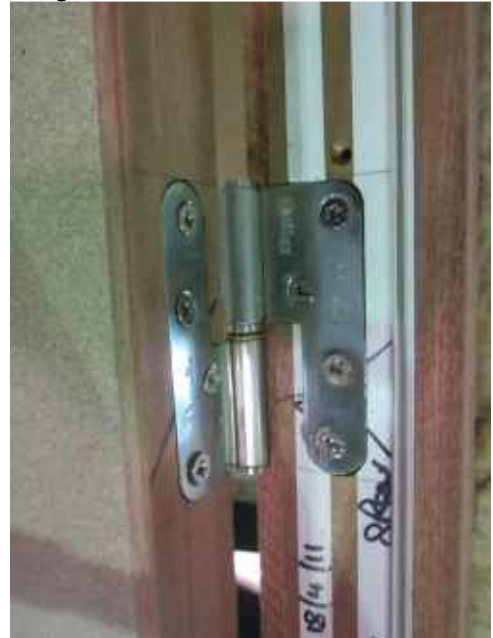
Hinge – doorset B

| | Make/type | Size (mm) | Location |
|---|---|---|---|
| Around hinges | Partially interrupted | - | Hinge blade fully interrupts 1 <sup>st</sup> seal and partially interrupts 2 <sup>nd</sup> seal leaving 11mm continuous in the frame reveal |
| Under hinge blade | Firestop Manufacturing Ltd intumescent sheet material<br>Product reference FS318 | 0.8 thick | Fitted under the hinge blade on frame and leaf |

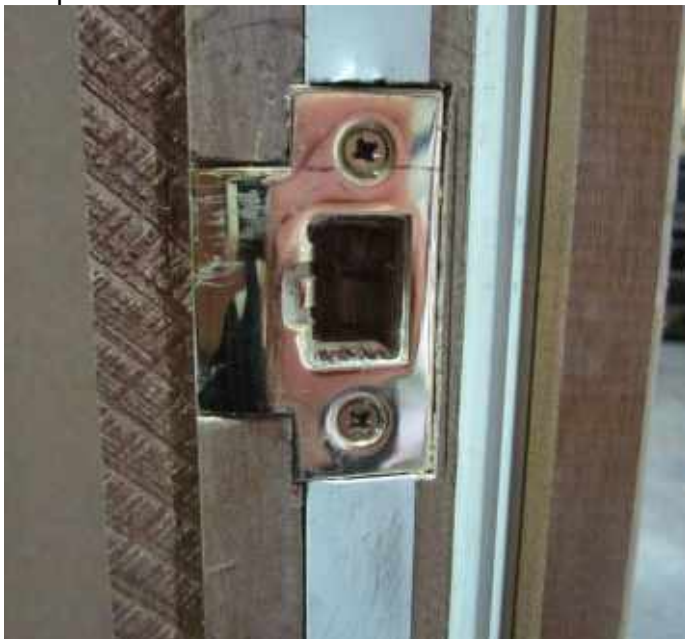
Keep – doorset A

| | Make/type | Size (mm) | Location |
|---|---|---|---|
| Around latch keep | Fully interrupted | - | Latch keep fully interrupts seal in frame reveal |
| Under latch keep | Interdens | 1 thick | Fitted under the latch keep |

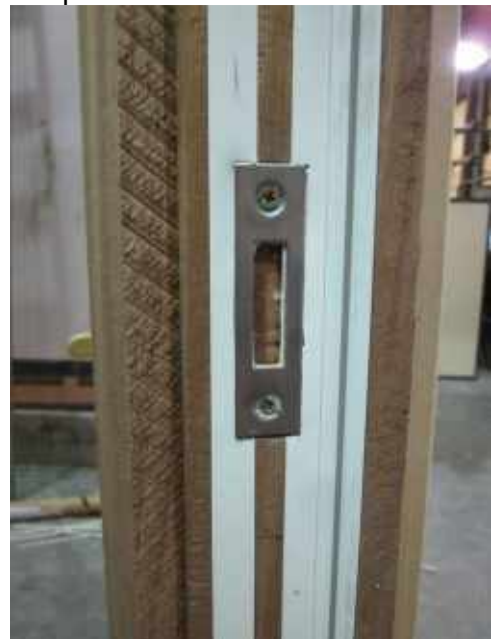
Keep – doorset B

| | Make/type | Size (mm) | Location |
|---|---|---|---|
| Around dead bolt keep | Partially interrupted | - | Latch keep partially interrupts both seals in the frame reveal with 7mm of the 1 <sup>st</sup> seal and 8mm of the 2 <sup>nd</sup> seal remaining continuous |
| Under latch keep | Interdens | 1 thick | Fitted under the latch keep |

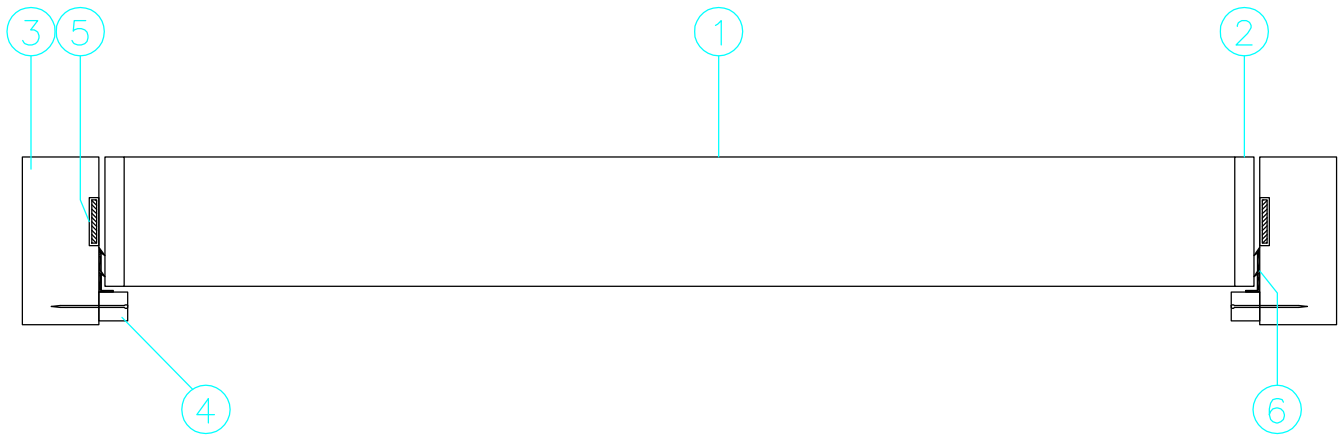
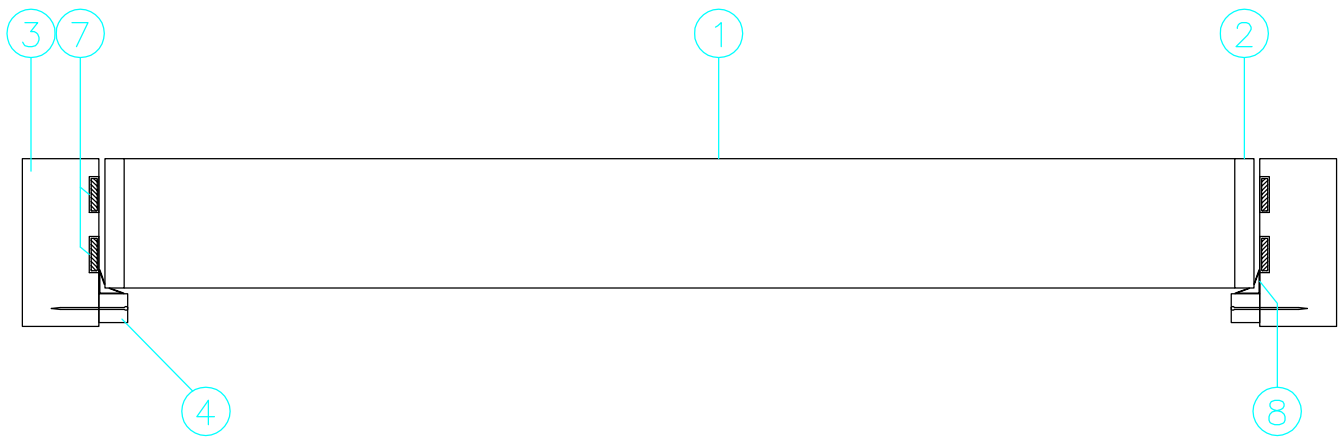
Horizontal cross-sections

#### 4 Description of construction (refers to Figures 1 to 4 of the appendix)

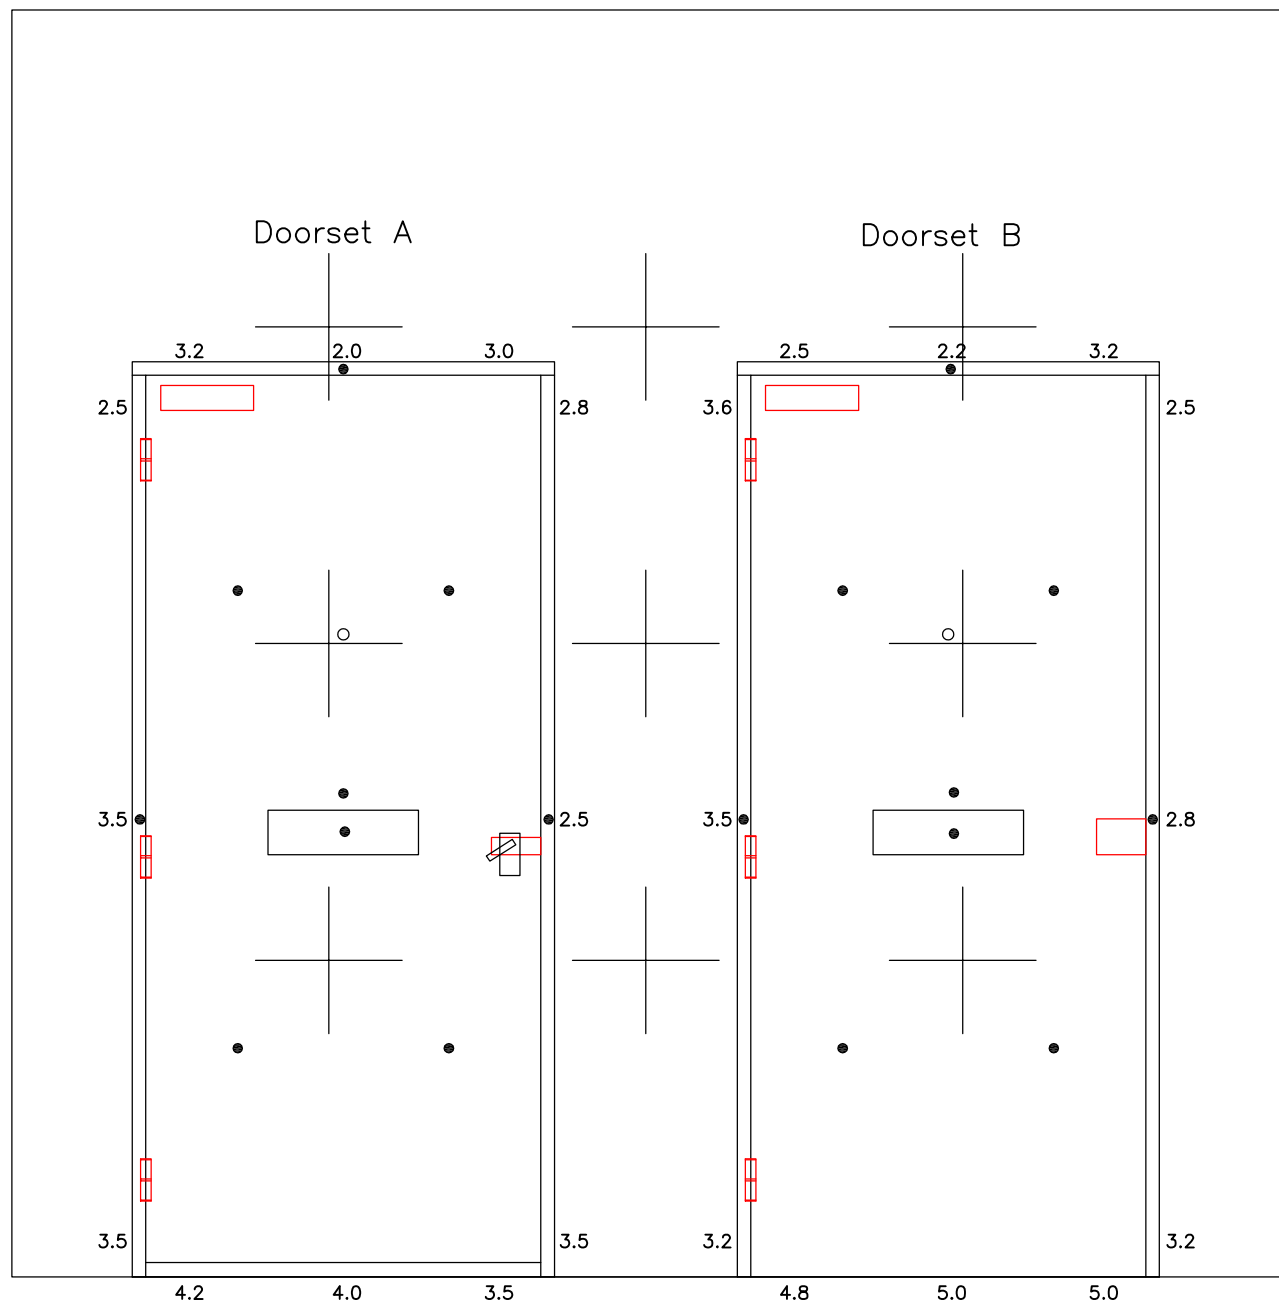
Title Thermocouple positions and  
door/frame gaps  
(All dimensions in mm)

The gaps between the edge of the leaves and frames were measured prior to test. A total of 24 readings were taken. The measurements (in mm) are given in Figure 4 of the Appendix.

The thermocouple positions are shown in Figure 4 of the appendix. The average temperature of the door leaf and maximum temperature of the doorset are shown graphically in Section 6.2.

The results of this test were obtained using the leaf to frame gaps recorded in Figure 4 of the appendix. The fire resistance performance of doors of this design may change if substantially different gaps are employed.
